# Vertical Recycle Paper Pulper

Make: Voith

Industry: Pulp and Paper

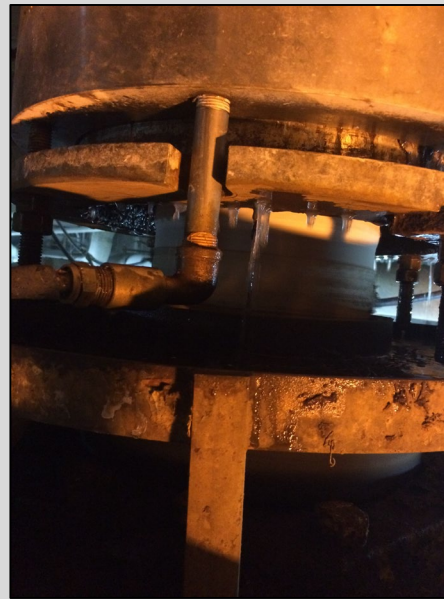
A paper recycling mill had a vertical pulper that was leaking continuously for years. Pulpers are notoriously difficult to seal due to extreme shaft movement along with abrasive materials in the tub. Multiple sealing solutions were attempted, including a variety of packing types, but none lasted more than 3 weeks. The leakage was causing housekeeping and safety issues and required constant oil changes in the gearbox below due to water ingress.

**Before:** Pulper drive shaft

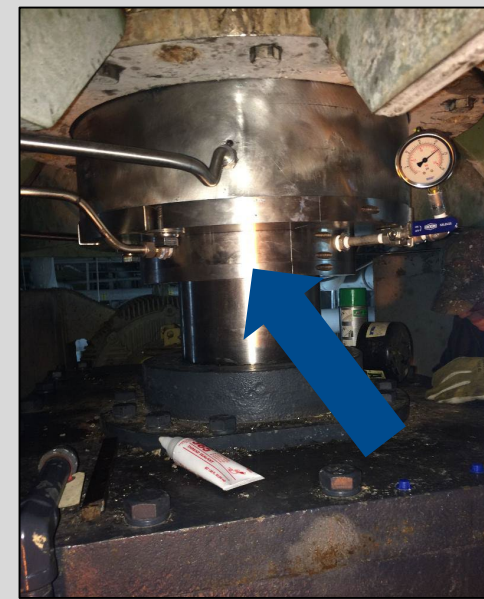
After installation, the Air Mizer stopped all water and paper stock leakage from the pulper tub. The area below the pulper is now completely dry, making it safe for personnel to perform inspections and preventative maintenance checks. In addition, because there is no leakage, frequent gearbox oil changes have been eliminated.

**After:** Pulper drive shaft with Inpro/Seal Air Mizer shaft seal in operation

An Inpro/Seal® Air Mizer® shaft seal was installed in April of 2016. The Air Mizer is a non-contacting, non-wearing shaft seal that utilizes a positive air purge to permanently protect against product loss and contamination. Its unique zero-maintenance design can fully articulate to handle angular, radial and axial shaft movement simultaneously.

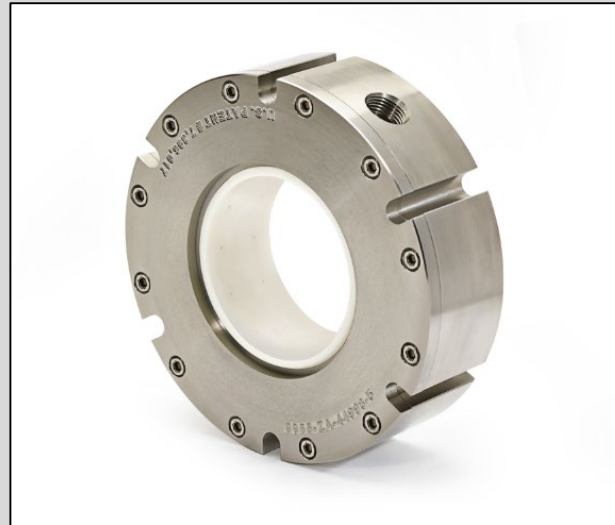
Inpro/Seal Air Mizer shaft seal
